**National  
Transportation  
Safety Board**

# Investigative Update of Battery Fire Japan Airlines B-787 - Jan 7, 2013

*January 24, 2013*

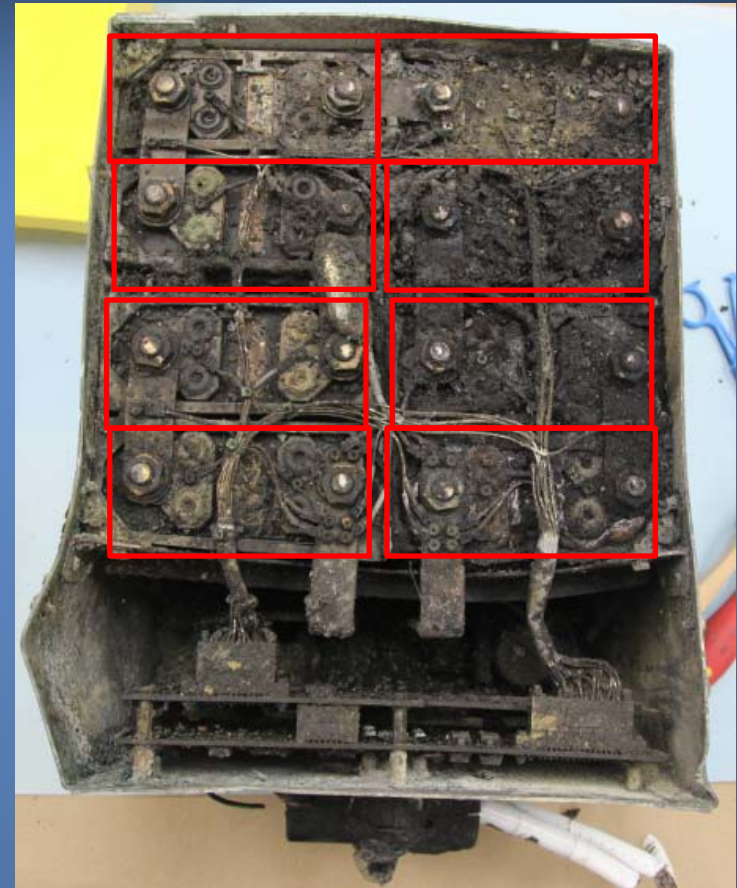
JAL Event Battery

# JAL APU Battery Cells

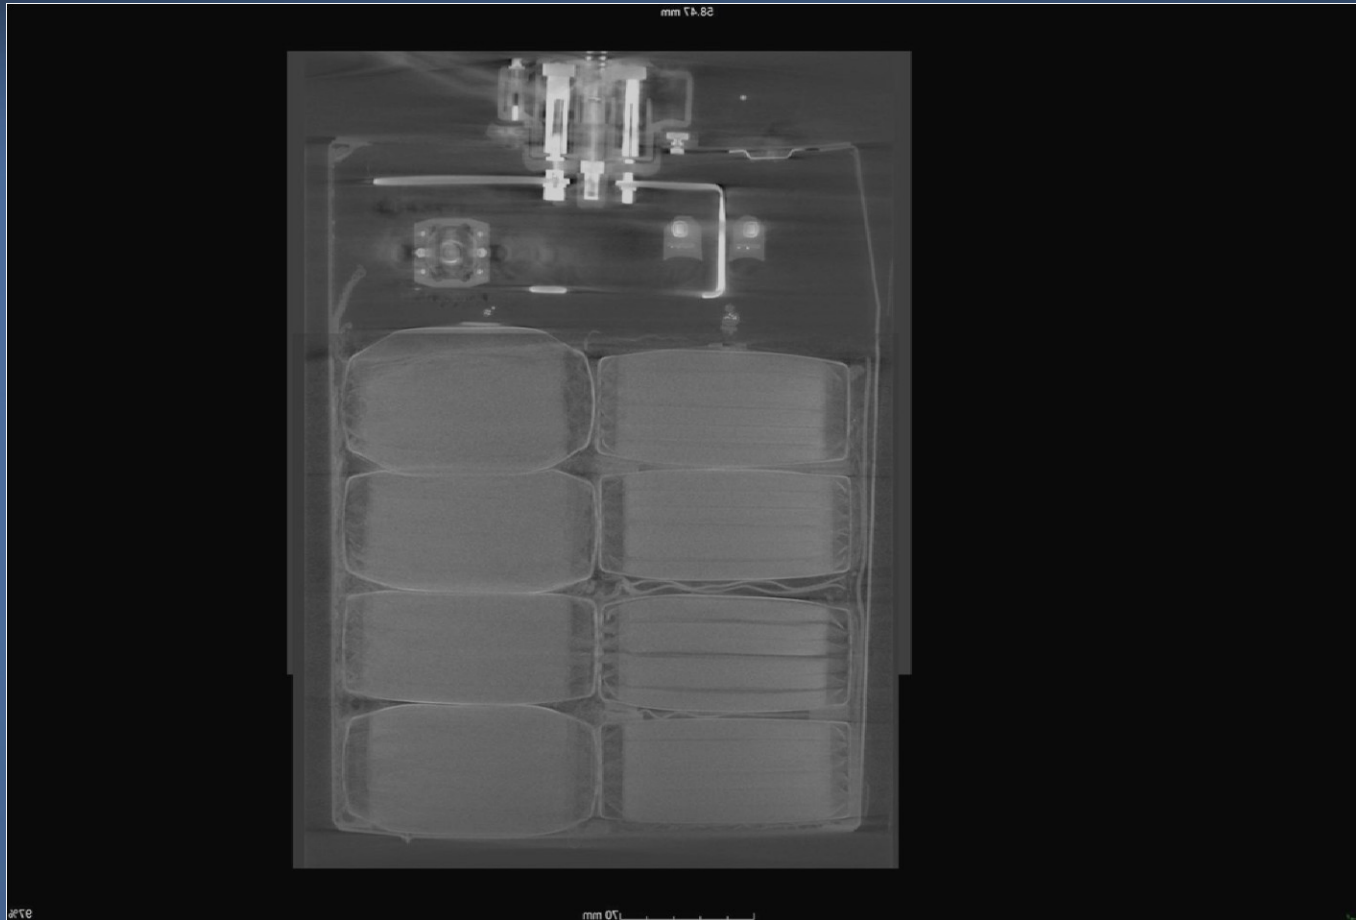
# CT Scan of Battery

# Findings To Date

- Fire was present
- Signs of thermal runaway
- Signs of electrical short circuiting
